# Intel® Celeron® Processor in the 478-Pin Package

Specification Update

Document Number: 290749-031

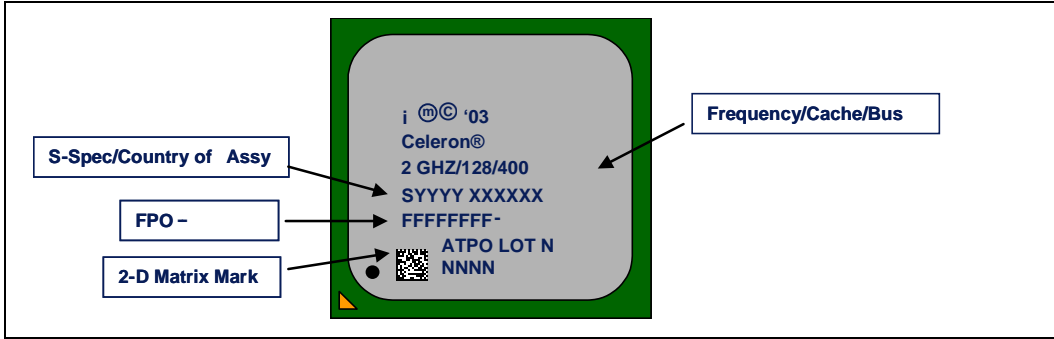
**Figure 1. Example Markings for the Intel® Celeron® Processor on 0.13 Micron Process and/or in the 478-Pin Package**

This section contains top marking information for the Intel® Celeron® processor in the 478-pin package.
